# A-1 Home Inspection Service, LLC

# Home Inspection Report 134 Travelier Trail Piedmont, SC

Inspection Date: 09/25/2018

Report Number: 08175

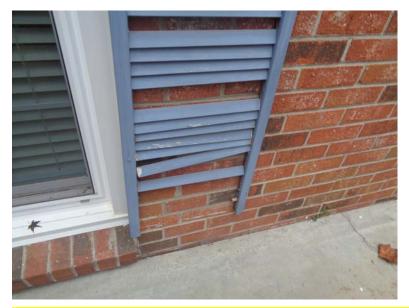
**Repair:** At the front of the house noted several damaged window wood shutters.

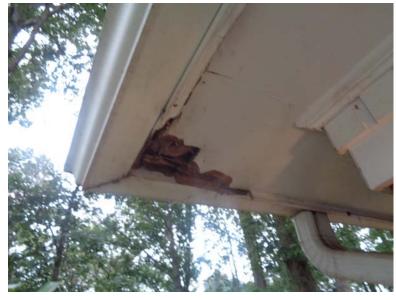
**Repair:** Noted wood decay behind the gutters at the fascia board located at the front right and rear right corners of the house.

**Repair:** Observed rot/damage to the fascia board across the front of the garage and at the left corner of the garage. Also the soffit is damaged at the left corner of the garage.

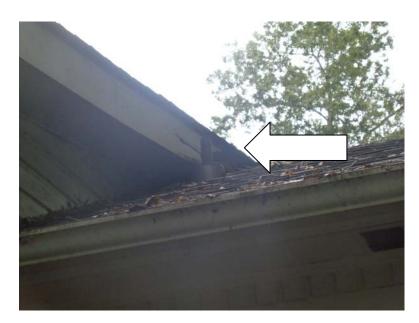
**Repair:** The fascia board at the right side of the screen porch is rotten/damaged where the board is butted into the roof. The board needs to be replaced.

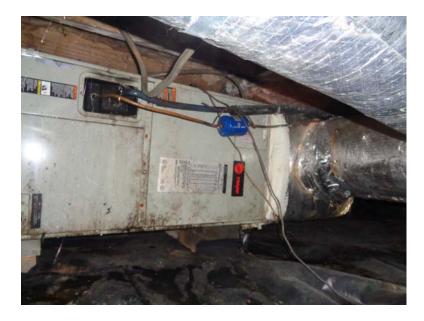
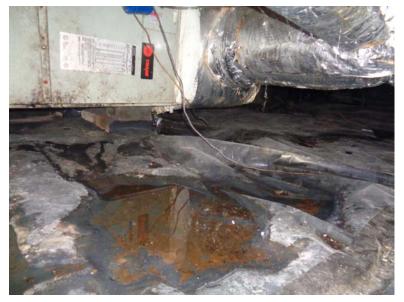
**Repair:** In the crawl space the air conditioning handler unit and /or condensation drain pipe is clogged by evidence of water dipping from the bottom of the handler unit and standing water on the ground. There was no water observed draining from the PVC drain pipe that extends to the exterior right side of the house. Recommend licensed HVAC technician to service the unit.

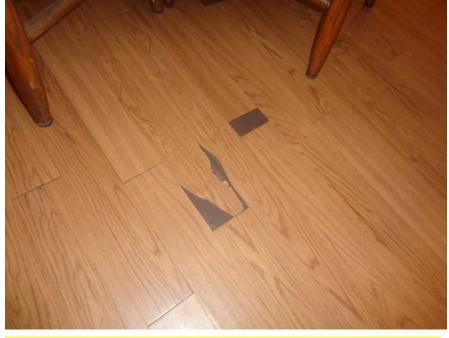
**Improve:** In the breakfast area noted damaged to several flooring boards.

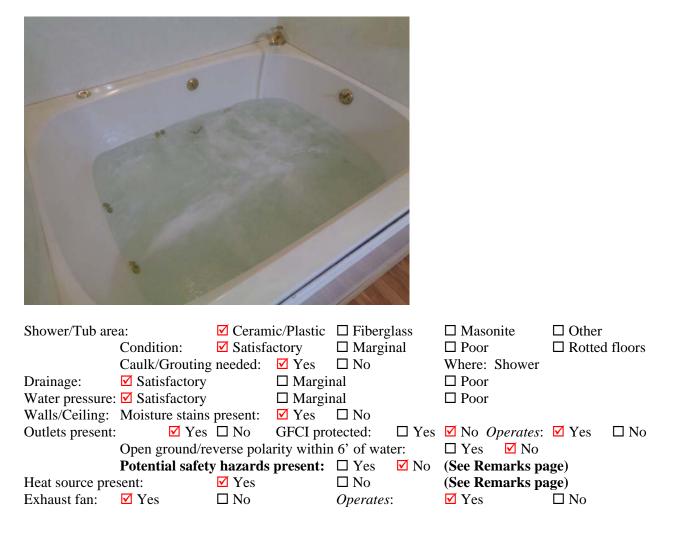
**Repair:** At the Whirlpool bathtub the hot water faucet leaks water. The faucet set needs to be replaced.

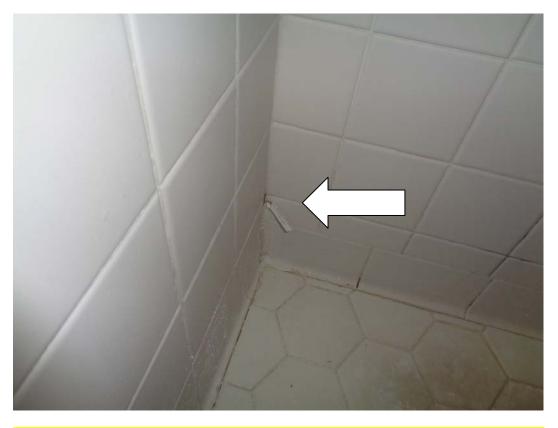
**Repair:** In the master bathroom noted missing/damaged caulking at the shower tile walls.

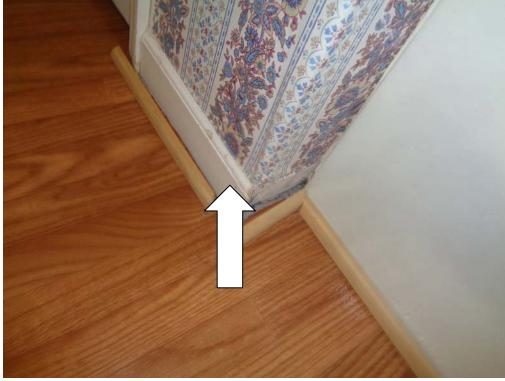
**Repair:** In the master bathroom the quarter round molding and the baseboard around the walls at the bathtub need to be installed.

**Monitor:** Observed an old water stain at the master bathroom that probably occurred when the past roof shingles.

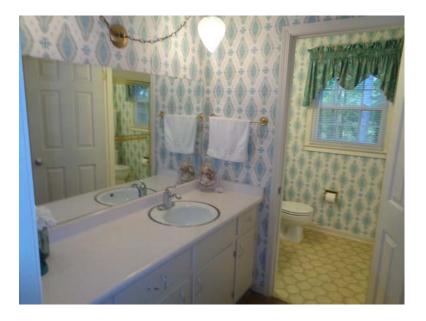
**Repair:** In the hall bathroom at the 2<sup>nd</sup> floor bathtub faucet drips water.

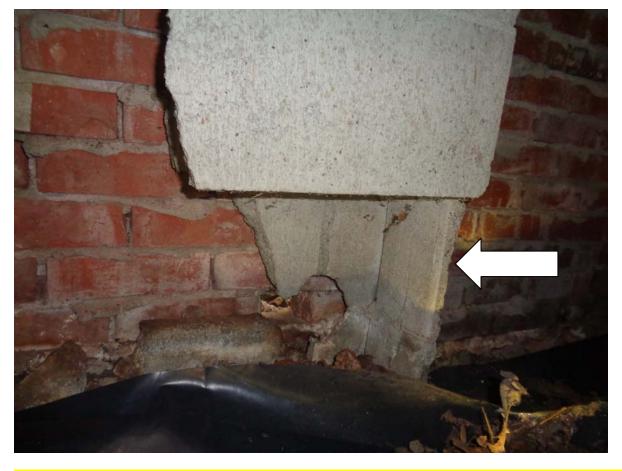
**Major Concern**: In the crawl space at the rear foundation wall at the Kitchen noted that block pier that be damaged removed with only a small piece that is supporting the two block above and the floor system. The pier needs to be repaired before the blocks fall causing major floor sagging.

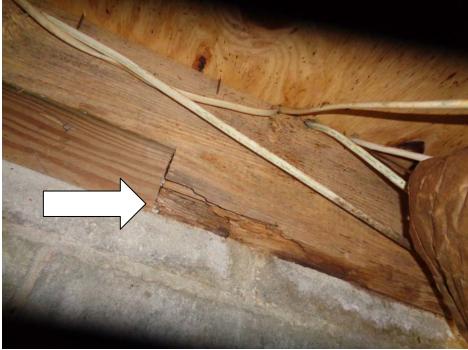
**Repair:** In the crawl space under the front door noted repairs to the sill plate, however noted damage wood that was not removed. Recommend licensed contractor to review to determine if repairs are needed.
