# *A-1 Home Inspection Service, LLC*

## **Home Inspection Report 585 Allenton Way Greer, SC**

**Inspection Date:**  
04/10/18

**Report Number:**  
07791

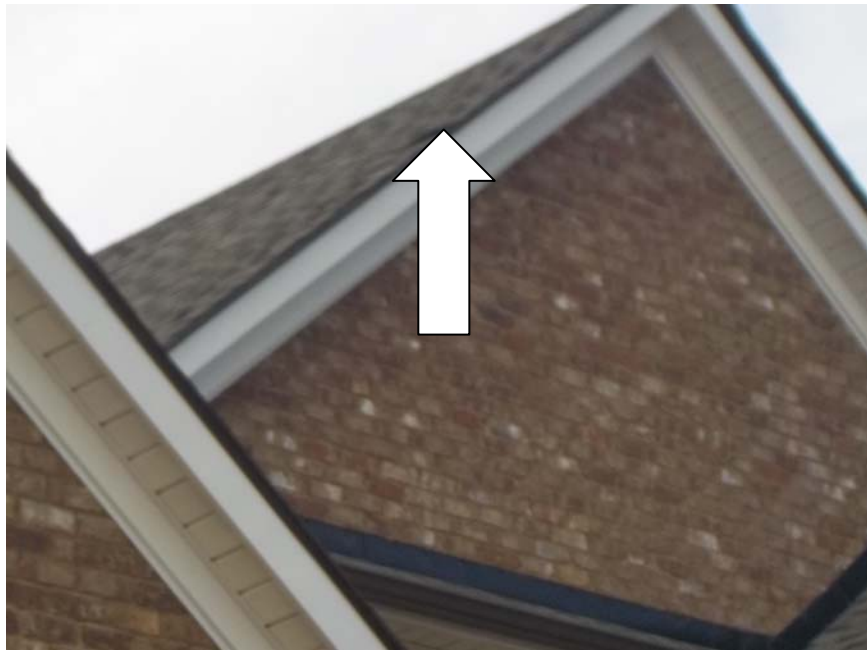
**Repair:** At the front middle of the house observed raised roof shingle at the left side of the gable area. At the soffit overhang. Recommend licensed roofer for repairs.

**Repair:** At the front middle of the house observed raised roof shingle at the left side of the gable area. At the soffit overhang. Recommend licensed roofer for repairs.

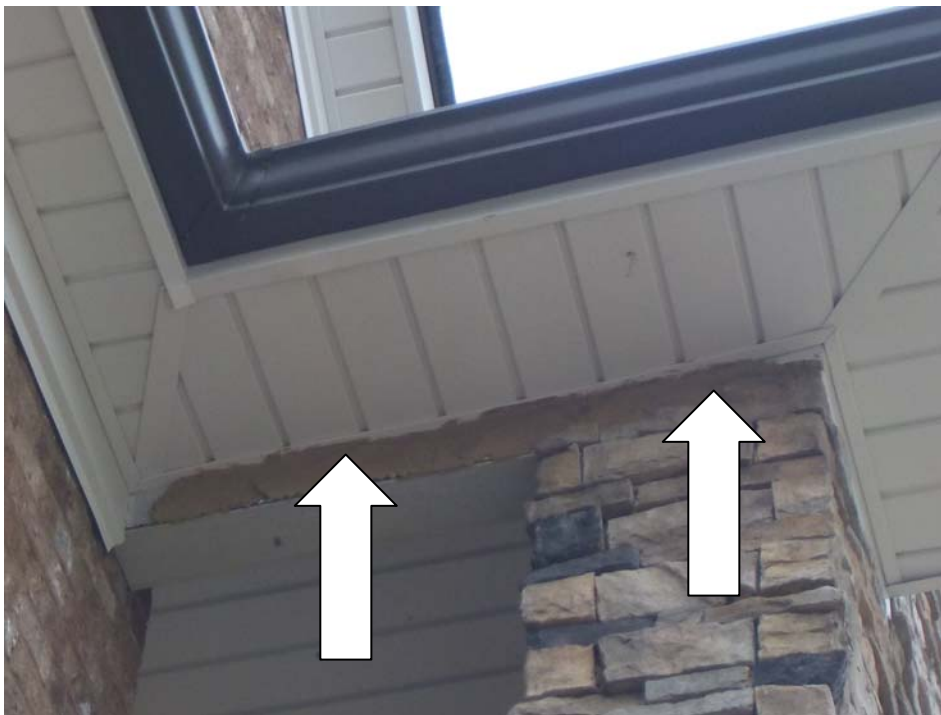
**Repair:** At the left side of the front porch the stone siding is missing at the top of the support column. Also, metal freeze board flashing is missing.

**Repair:** At the left side of the front porch the stone siding is missing at the top of the support column. Also, metal freeze board flashing is missing.

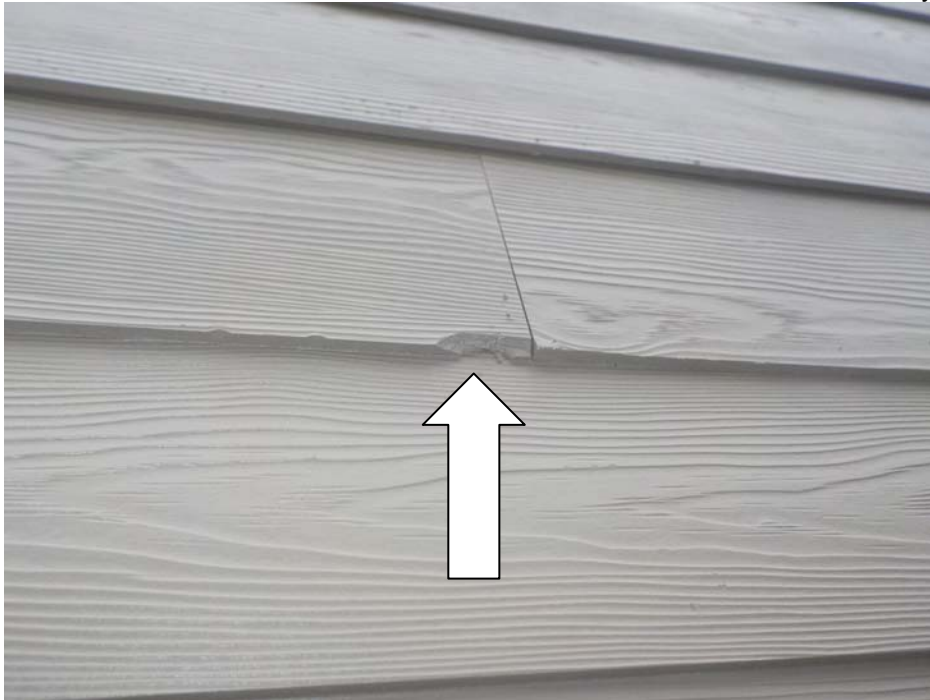
**Safety Issue:** Observed damaged Hardi board boards at the right and left side of the house. The damaged is at the bottom end of the boards. These boards should be replaced.

**Repair:** Observed damaged Hardi board boards at the right and left side of the house. The damaged is at the bottom end of the boards. These boards should be replaced.

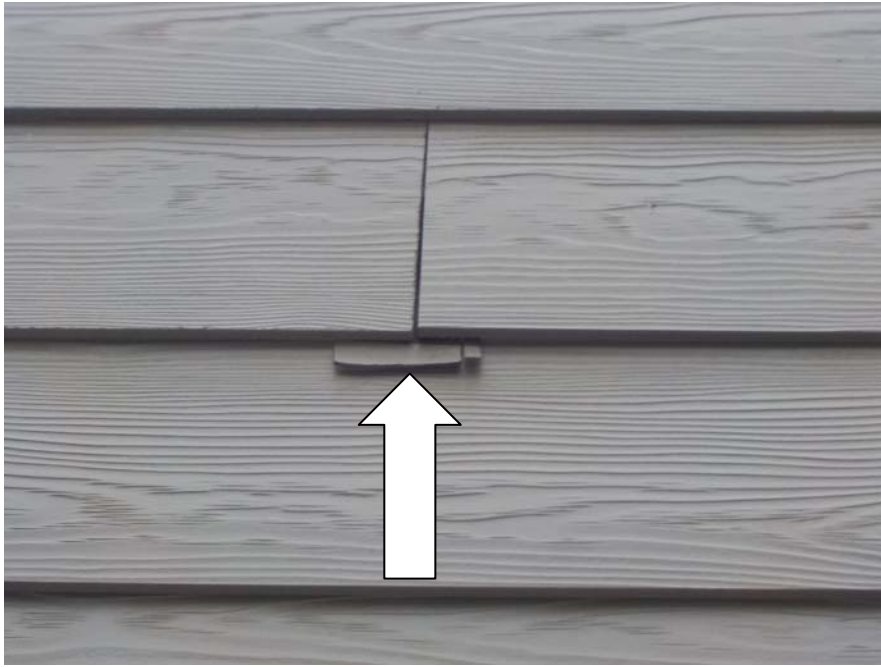
**Repair:** Around the house observed moisture barrier paper material installed under the Hardi board that is extending to the exterior. The moisture material needs to cut-off / removed from the exterior of the siding.

**Repair:** Around the house observed moisture barrier paper material installed under the Hardi board that is extending to the exterior. The moisture material needs to cut-off / removed from the exterior of the siding.

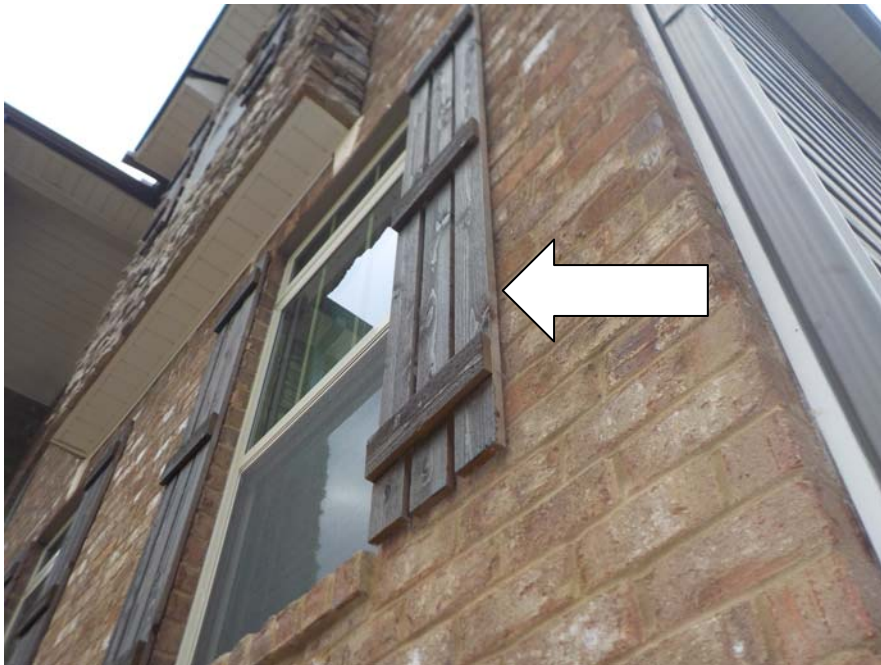
**Repair:** At the front right side of the house the right side of the window shutter is missing stain.

**Repair:** At the front right side of the house the right side of the window shutter is missing stain .

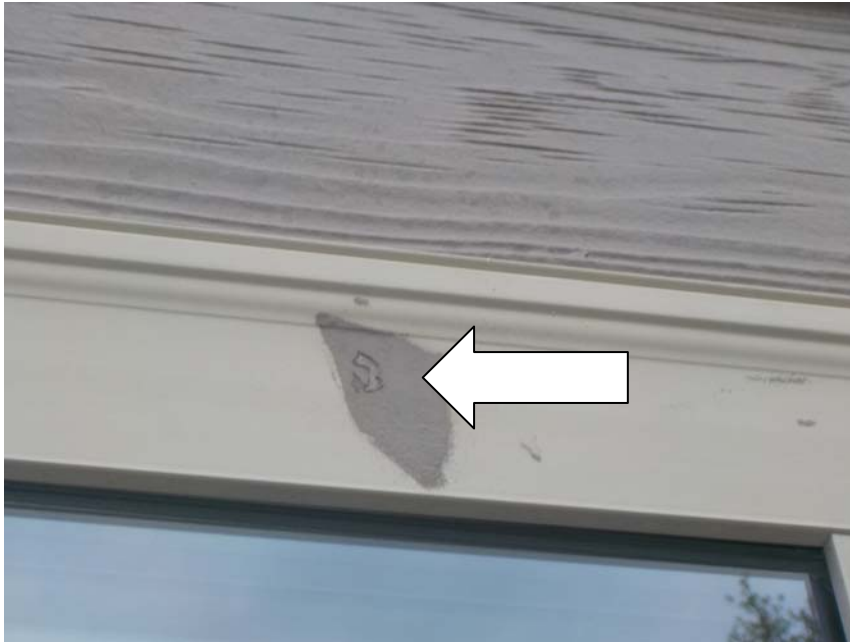
**Repair:** Observed gray siding paint spots on various vinyl windows frames located at the rear of the house.

**Repair:** Observed gray siding paint spots on various vinyl windows frames located at the rear of the house.

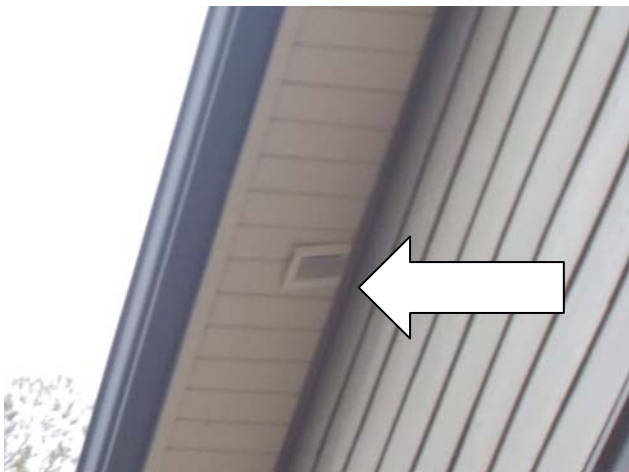
**Repair:** At the left side of the house observed a exhaust vent fan that is detached at the vinyl soffit.

**Repair:** At the left side of the house observed a exhaust vent fan that is detached at the vinyl soffit.

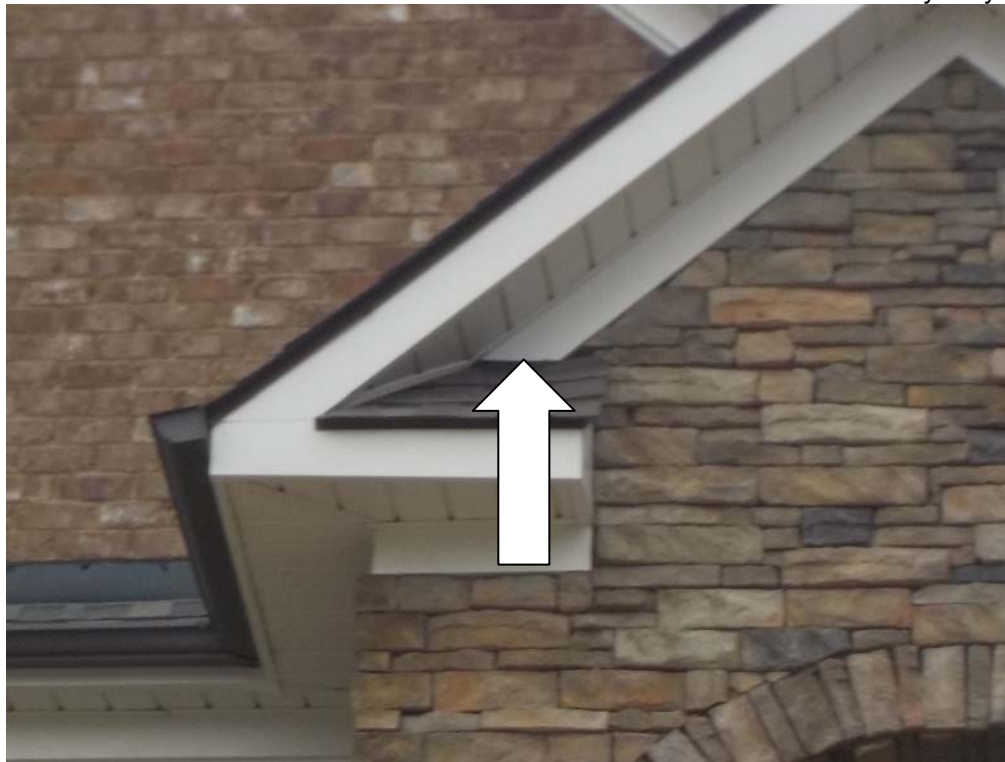
**Repair:** At the front left side of the front porch at the eve the metal aluminum freeze board is cut short causing an opening at the top of the roof shingle return. Storm water could enter causing rood decay.

**Repair:** At the front left side of the front porch at the eave the metal aluminum freeze board is cut short causing an opening at the top of the roof shingle return. Storm water could enter causing rood decay.

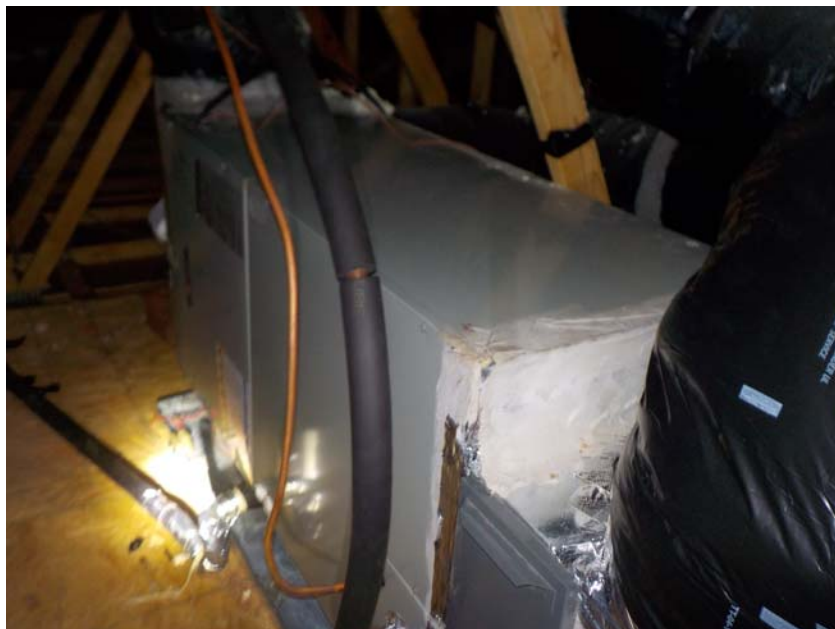
| Operated: | When turned on by thermostat: <input checked="" type="checkbox"/> Fired <input type="checkbox"/> Did not fire |
| Operation: | Satisfactory: <input checked="" type="checkbox"/> Yes <input type="checkbox"/> No <input type="checkbox"/> <b>Recommend HVAC technician examine</b> |

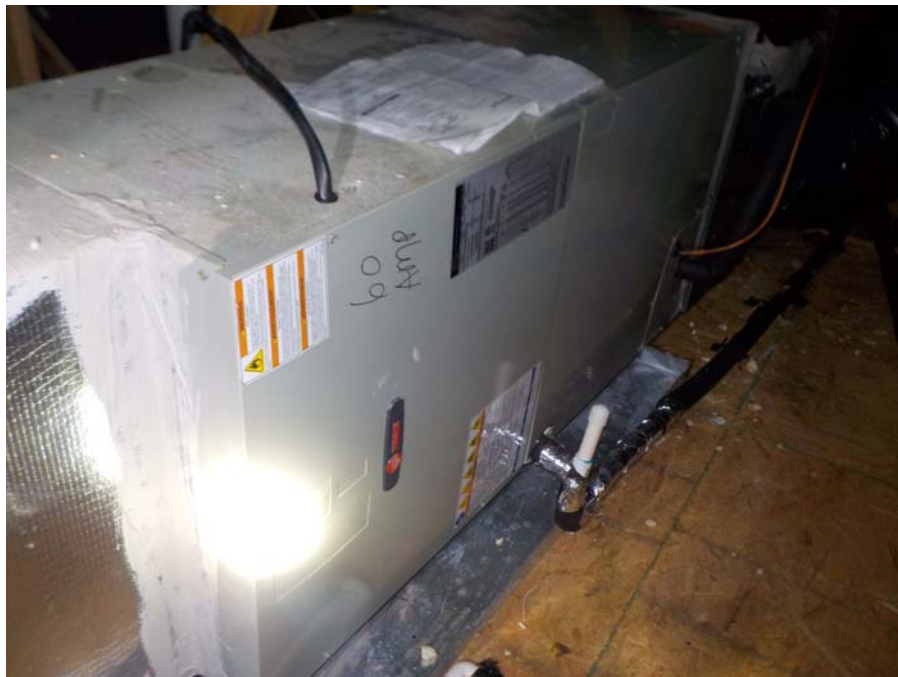
**Forced Air System**

**Basement** Brand name: Trane Model# ? Approx. age: 0 Years Unit located in Basement

Energy source:  Gas  LP  Oil  Electric  
 Hot air systems:  Belt drive  Direct drive  Gravity  
 Heat exchanger:  Visual with mirror  N/A (sealed)  Not accessible  
 Condition:  Rusted  Flame distortion  Other  
**View is extremely limited - See Remarks page about options**  
 Heat pump:  Aux. Elec.  Aux. Gas  Aux. geothermal  N/A  
 Emergency heat tested:  Yes  No  N/A  
 CO test: Tester:  Plenum/register  Not tested  N/A  
 Distribution:  Metal duct  Insul. flex duct  Cold air returns  
 Flue piping:  Metal  PVC  Proper pitch  Rusted  N/A  
 Filter:  Standard  Electrostatic  Paper  N/A  
 Condition:  Satisfactory  Replace/clean  Missing  
 Operated: When turned on by thermostat:  Fired  Did not fire  
 Operation: Satisfactory:  Yes  No  **Recommend HVAC technician examine**

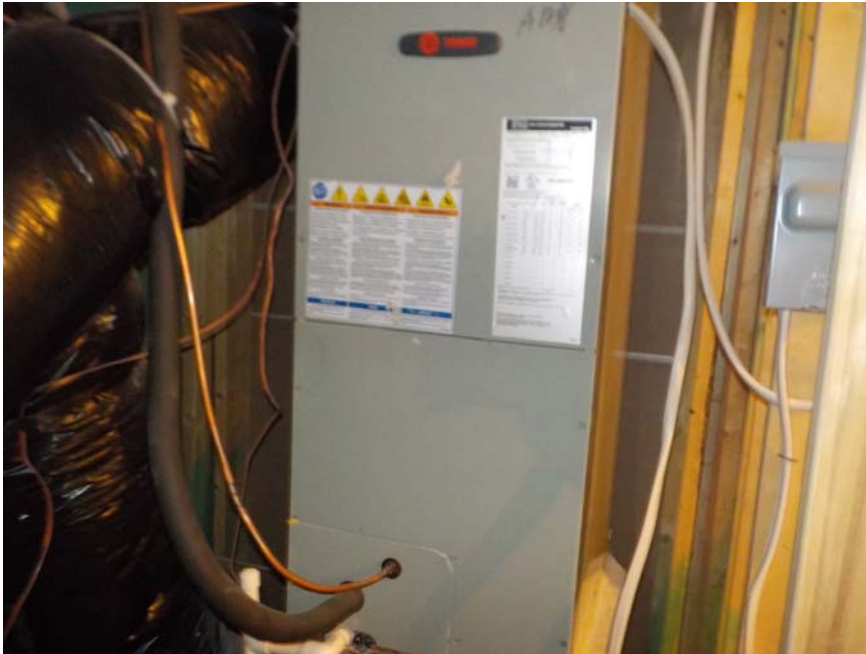
**The heating system is in generally good condition. The heating system shows no visible evidence of major defects.**

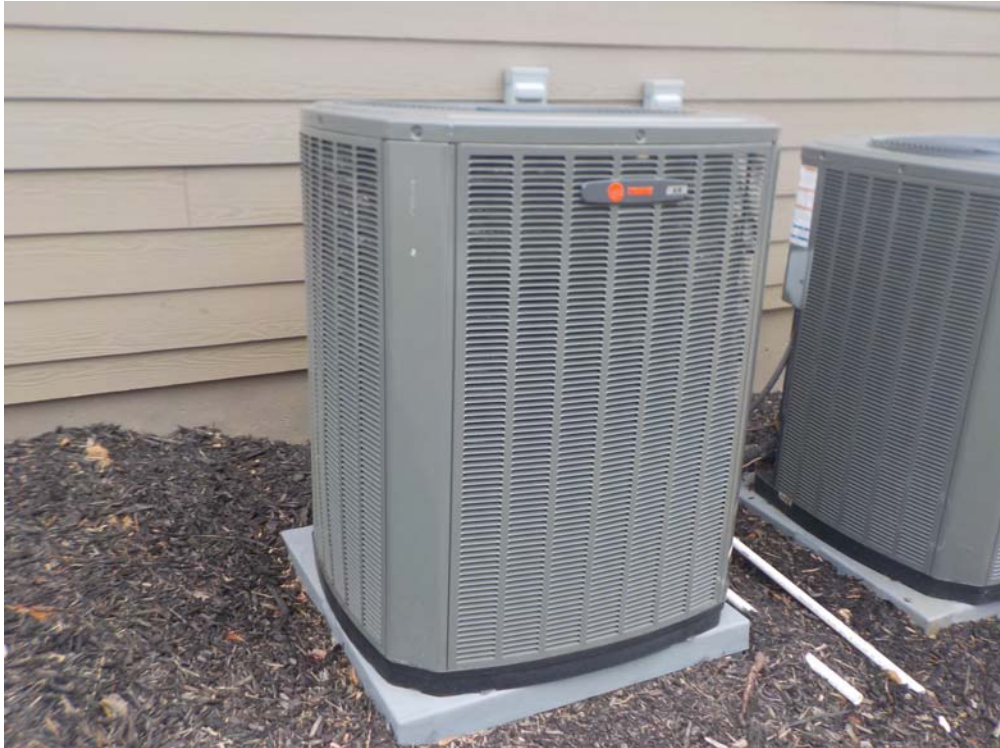
**A/C Condenser (---2<sup>nd</sup> floor)**  None  
 Brand name: Trane Model # 4TWR048100AA Serial# 171963GY2F Approx. age: 0 Yrs

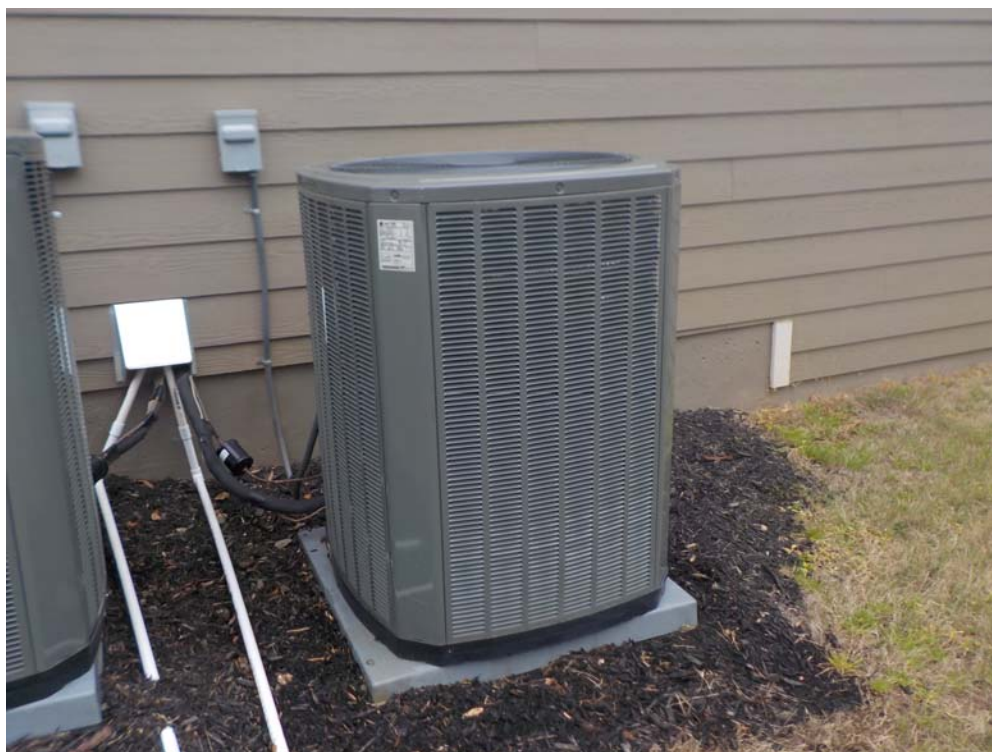
**A/C Condenser (Left ---Basement)**

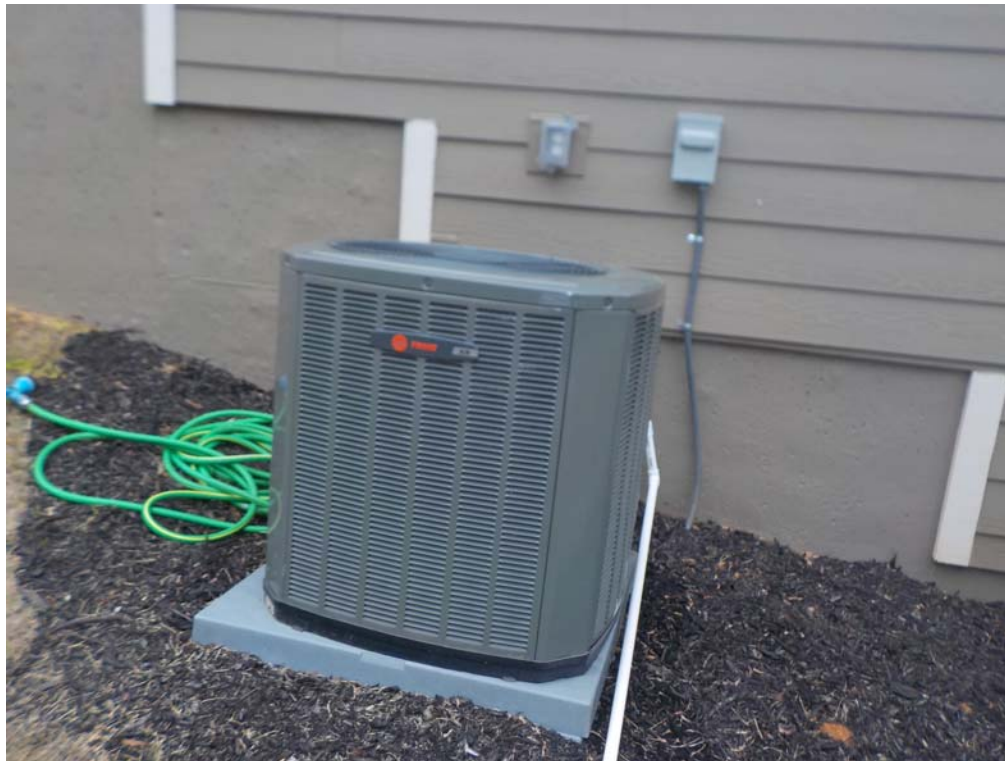
Refrigerant lines:  Leak  Damaged  Insulation missing  Satisfactory  
 Through wall unit(s):  N/A Operated:  Yes  No  Satisfactory  Needs service

**The cooling system is in generally good condition. The system shows no visible evidence of major defects.**

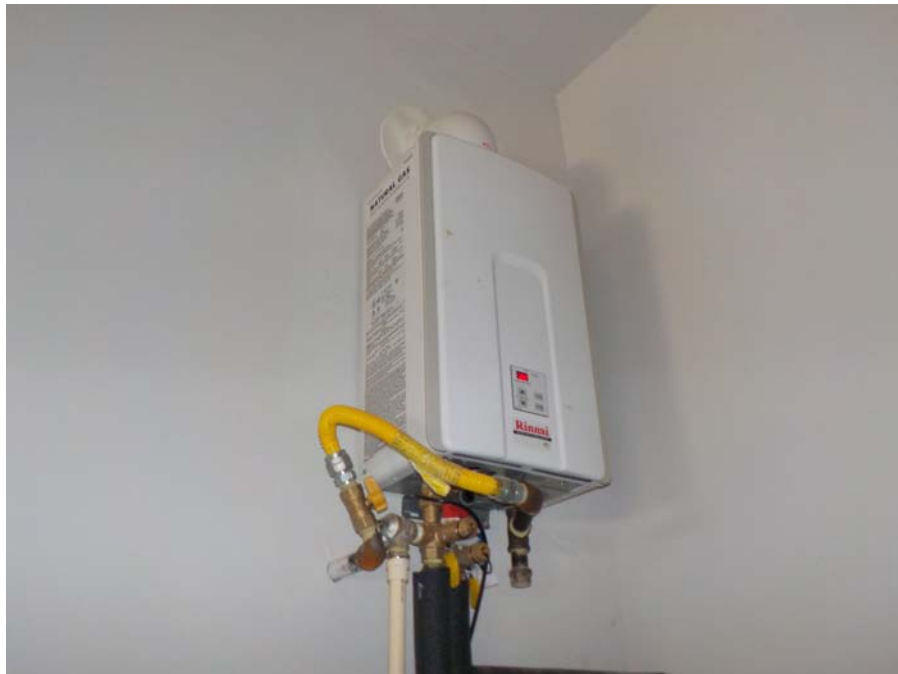
| Water Heater | |
|---|---|
| Relief valve: | <input checked="" type="checkbox"/> Yes <input type="checkbox"/> No <b>Extension proper:</b> <input checked="" type="checkbox"/> Yes <input type="checkbox"/> No <input type="checkbox"/> Missing |
| Vent pipe: | <input type="checkbox"/> N/A <input checked="" type="checkbox"/> Satisfactory <input checked="" type="checkbox"/> Pitch proper <input type="checkbox"/> Rusted <input type="checkbox"/> Other |

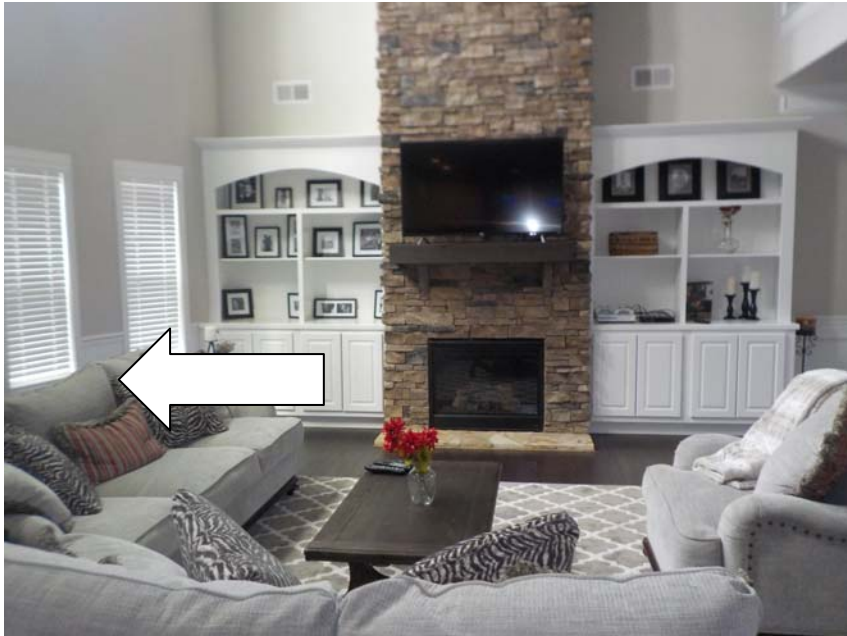
**Repair:** In the Family room observed numerous wall defects at the rear wall at the white wall painted area and at the gray painted wall.

**Repair:** In the Family room observed numerous wall defects at the rear wall at the white wall painted area and at the gray painted wall.

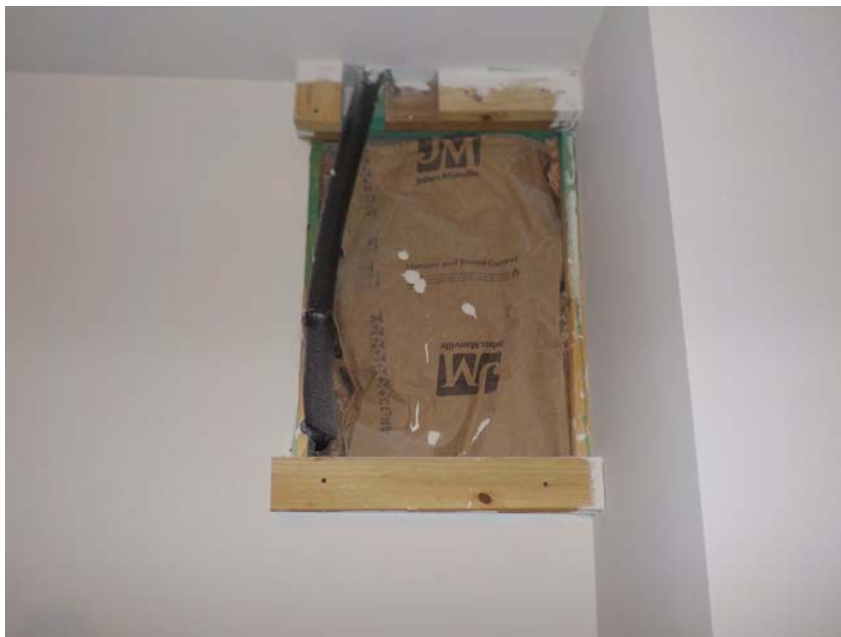
**Repair:** In the exercise room observed two cut out areas in the sheet rock wall.

**Repair:** In the exercise room observed two cut out areas in the sheet rock wall.
