# A-1 Home Inspection Service, LLC

# Home Inspection Report 134 Travelier Trail Piedmont, SC

Inspection Date: 09/25/2018

Report Number: 08175

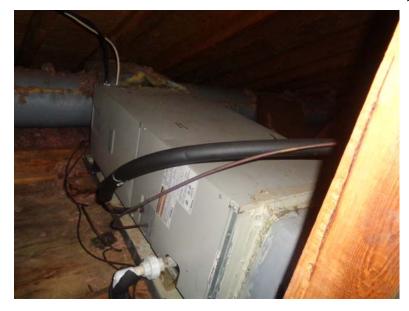
**Unit#2** Brand name: Model# ? Approx. age: year(s) Located in Attic Space serviced the 2<sup>nd</sup> floor

Energy source:	□ Gas	$\Box$ LP	C	⊐ Oil	🗹 Electric	
Hot air systems:	□ Belt drive	🗹 Direct dı	rive [	□ Gravity		
Heat exchanger:	$\Box$ Visual with mirror		$\Box$ N/A (sealed)		✓ Not accessib	le
	Condition:	□ Rusted	🗆 Flan	ne distortion	$\Box$ Other	
	View is extrem	ely limited	- See Re	emarks page a	bout options	
Heat pump:	$\Box$ Aux. Elec.	🗆 Aux. Ga	s E	□ Aux. geother	rmal 🛛 N/A	
	Emergency hea	t tested:	$\Box$ Yes	🗆 No	☑ N/A	
CO test:	Tester:		□ Plen	um/register	$\Box$ Not tested	☑ N/A
Distribution:	□ Metal duct		🗹 Insu	l. flex duct	□ Cold air retu	rns
Flue piping:	□ Metal	$\Box$ PVC	🗆 Prop	per pitch	□ Rusted	☑ N/A
Filter:	🗹 Standard		$\Box$ Elec	ctrostatic	□ Paper	$\Box$ N/A
	Condition:	✓ Satisfact	ory	🗆 Replac	ce/clean	□ Missing
Operated:	When turned or	h by thermos	tat: 🛛	Fired	$\Box$ Did not fire	-

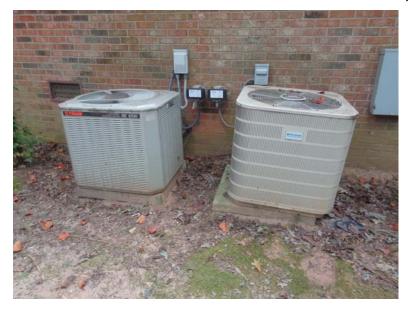
A/C Condenser (Right $2^{nd}$ floor) $\Box$ None				
Brand name: Fridgidaire Model # F38C-024K Serial# FTA0330401530	Approx. age: 15 Yrs			
Outside shutoff: ☑ Yes     □ No       Condition: ☑ Satisfactory □ Marginal     □ Poor     □ Rusted       Energy source: ☑ Electric     □ Gas     □ Other	Level: ☑ Yes □ No			
Operated:       □ Yes       ☑ No       □ Not operated due         Temperature differential       :Bedroom 13 °F Bedroom 13 °F Bedroom 13 °F         (See Remarks page)	Heat pump to outside temperature			
Refrigerant lines:□ Leak□ Damaged□ Insulation missinThrough wall unit(s):□ N/AOperated:☑ Yes□ No☑ Satist	factory			
<b>Repair:</b> The Frigidaire heat pump that services the 2 <sup>nd</sup> floor is 15 years old and	nearing the end of life.

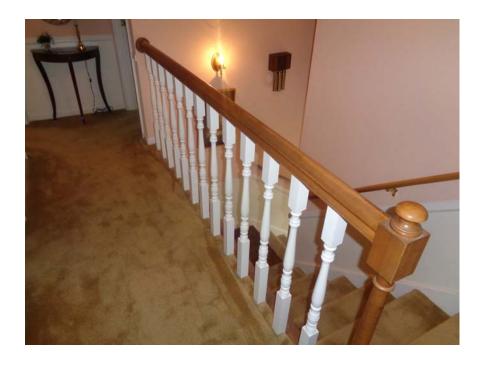
Interior Windows/Glass General condition: □ Surface deterioration: (See Rem	☑ Satisfactory arks page)   ☑ Re	☐ Marginal presentative num	□ Poor ber of windows operated
Evidence of leaking insulated glass: Hardware missing Glazin, Safetygkzingrequired NA What	☐ Yes g compound needed are:	☑ No □ Cracked gla	□ N/A ass
Stairs	✓ Satisfactory	□ Marginal	□ Poor □ None
Handrail: 🗆 Satisfa	ctory <b>I</b> Marginal	□ Poor	
Risers/Treads: ☑ Satisfa	ctory	□ Poor	□ Risers uneven
Safety Issue. The hand railing at th	e second floor is loose

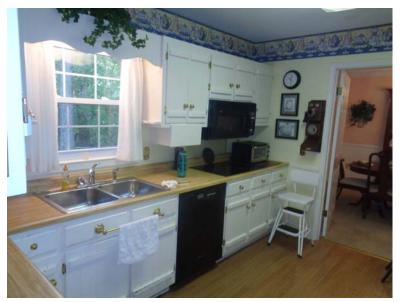
**View of Kitchen**

Monitor: Obs	erved old water	stains on the ceiling	g in the kitchen t	hat probably occur	red when the past roof
shingles.					
Electrical					
Outlets present:	✓ Yes	□ No	Operates:	☑ Yes	$\Box$ No
GFCI protected	: 🗹 Yes	□ No	Operates:	☑ Yes	□ No ( <b>Remarks</b> )
Open ground/re	verse polarity w	vithin 6' of water:	$\Box$ Yes	🗹 No	🗆 Safety hazard

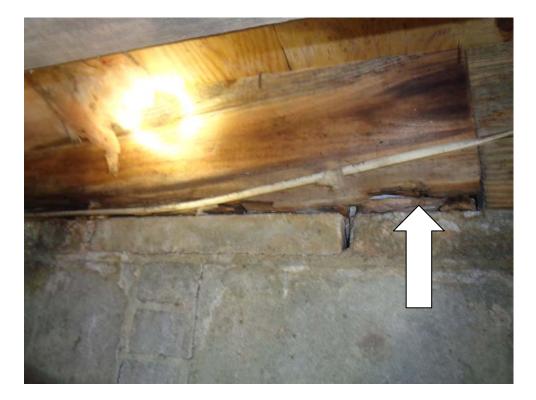
**Repair:** In the crawl space under the front door noted repairs to the sill plate, however noted damage wood that was not removed. Recommend licensed contractor to review to determine if repairs are needed.
